Værktøjer til mere bæredygtig renovering

Webinar 2024-06-11

NS-EN 17680:2023 Sustainable Construction “Evaluation of Sustainable Refurbishment potential”

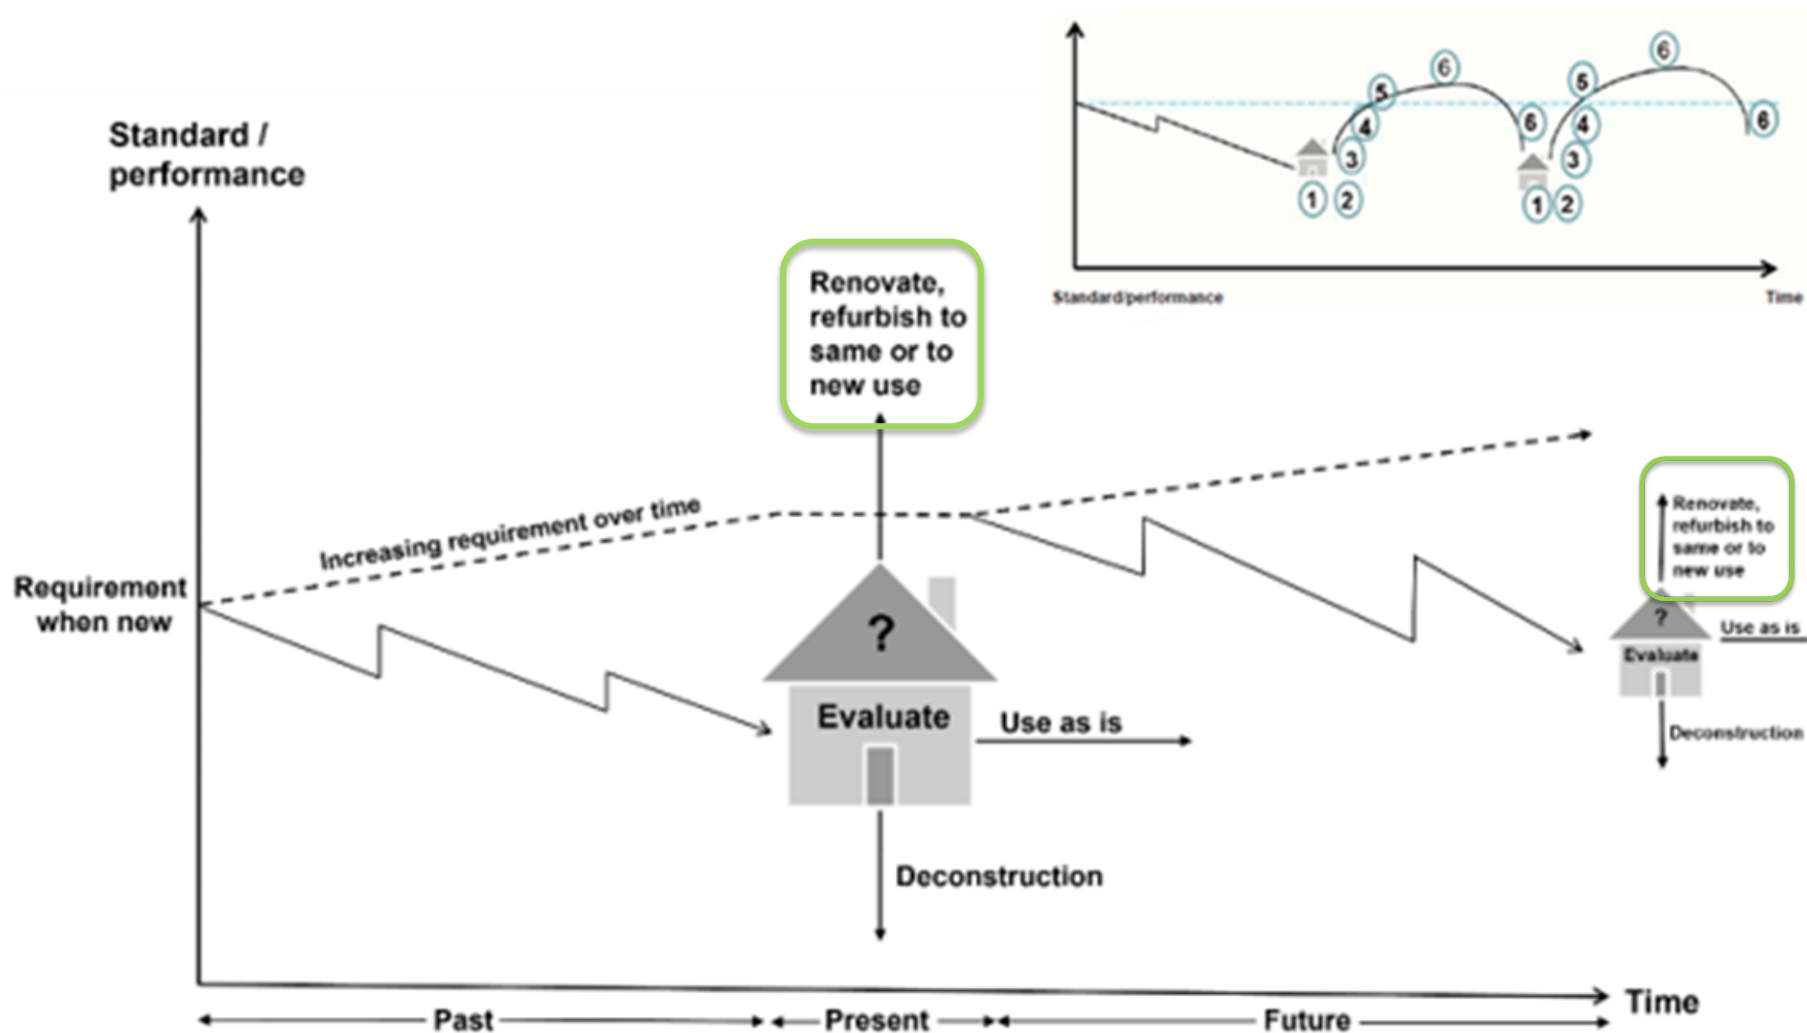
Decision methodology process

(Ref.: NS-EN 17680:2023, figure 1)

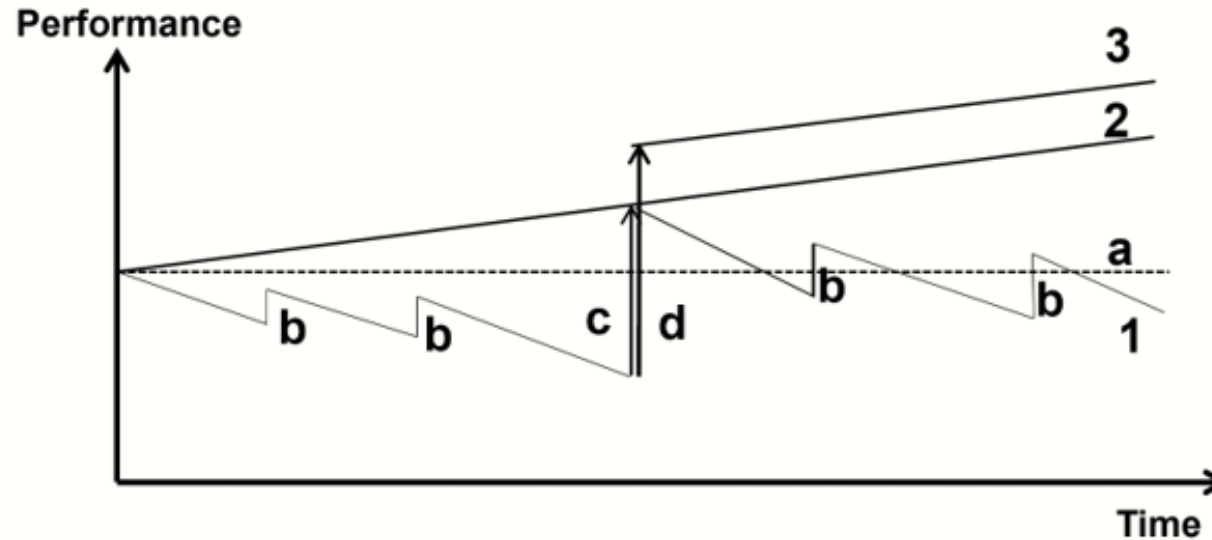
Renovation and refurbishment

Key

a Requirement at construction time as **new building**

b **Maintenance**

c Renovation: Upgrading the fabric/material, components and energy retrofit

d Refurbishment: Major renovation that can also include change of space distribution in connection with construction activities

1. Performance level with just maintenance and replacement of components, elements and systems, including new energy efficiency upgrade

2. **Upgrading level:** Technical upgrade to today's performance demands.

3. **Sustainability level:** New demands related to sustainability performance. (Renovation that also includes change space distribution)

(Ref.: prEN 17680 fig 5)

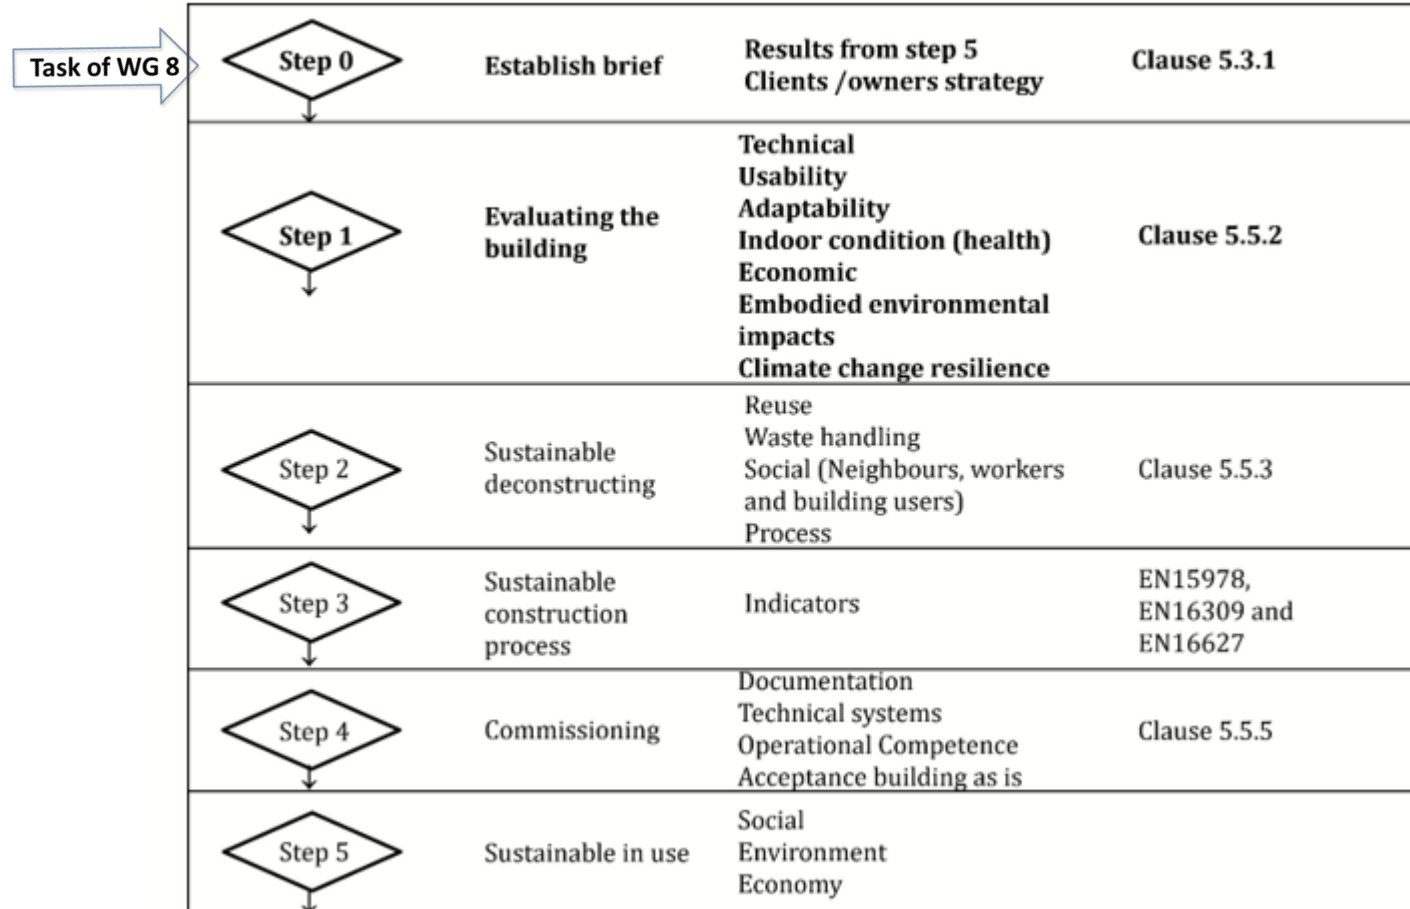
Step by step

(Ref.: prEN 17680, figure 8)

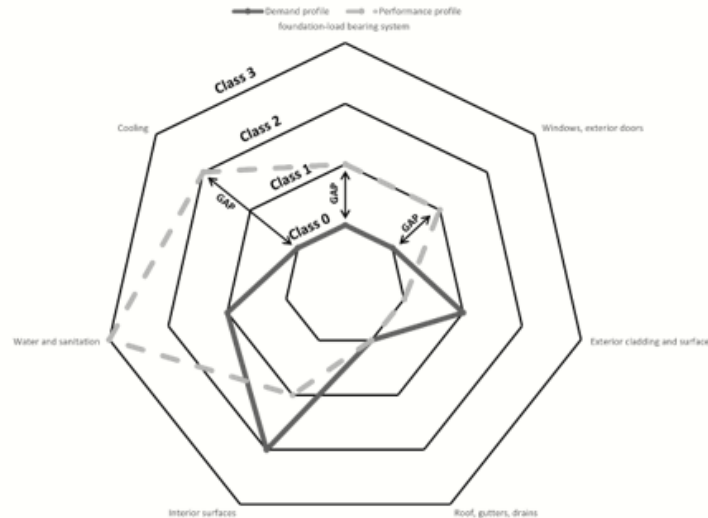
— Demand profile - - - Performance profile

(Ref.: prEN 17680, figure A 1 og A 2)

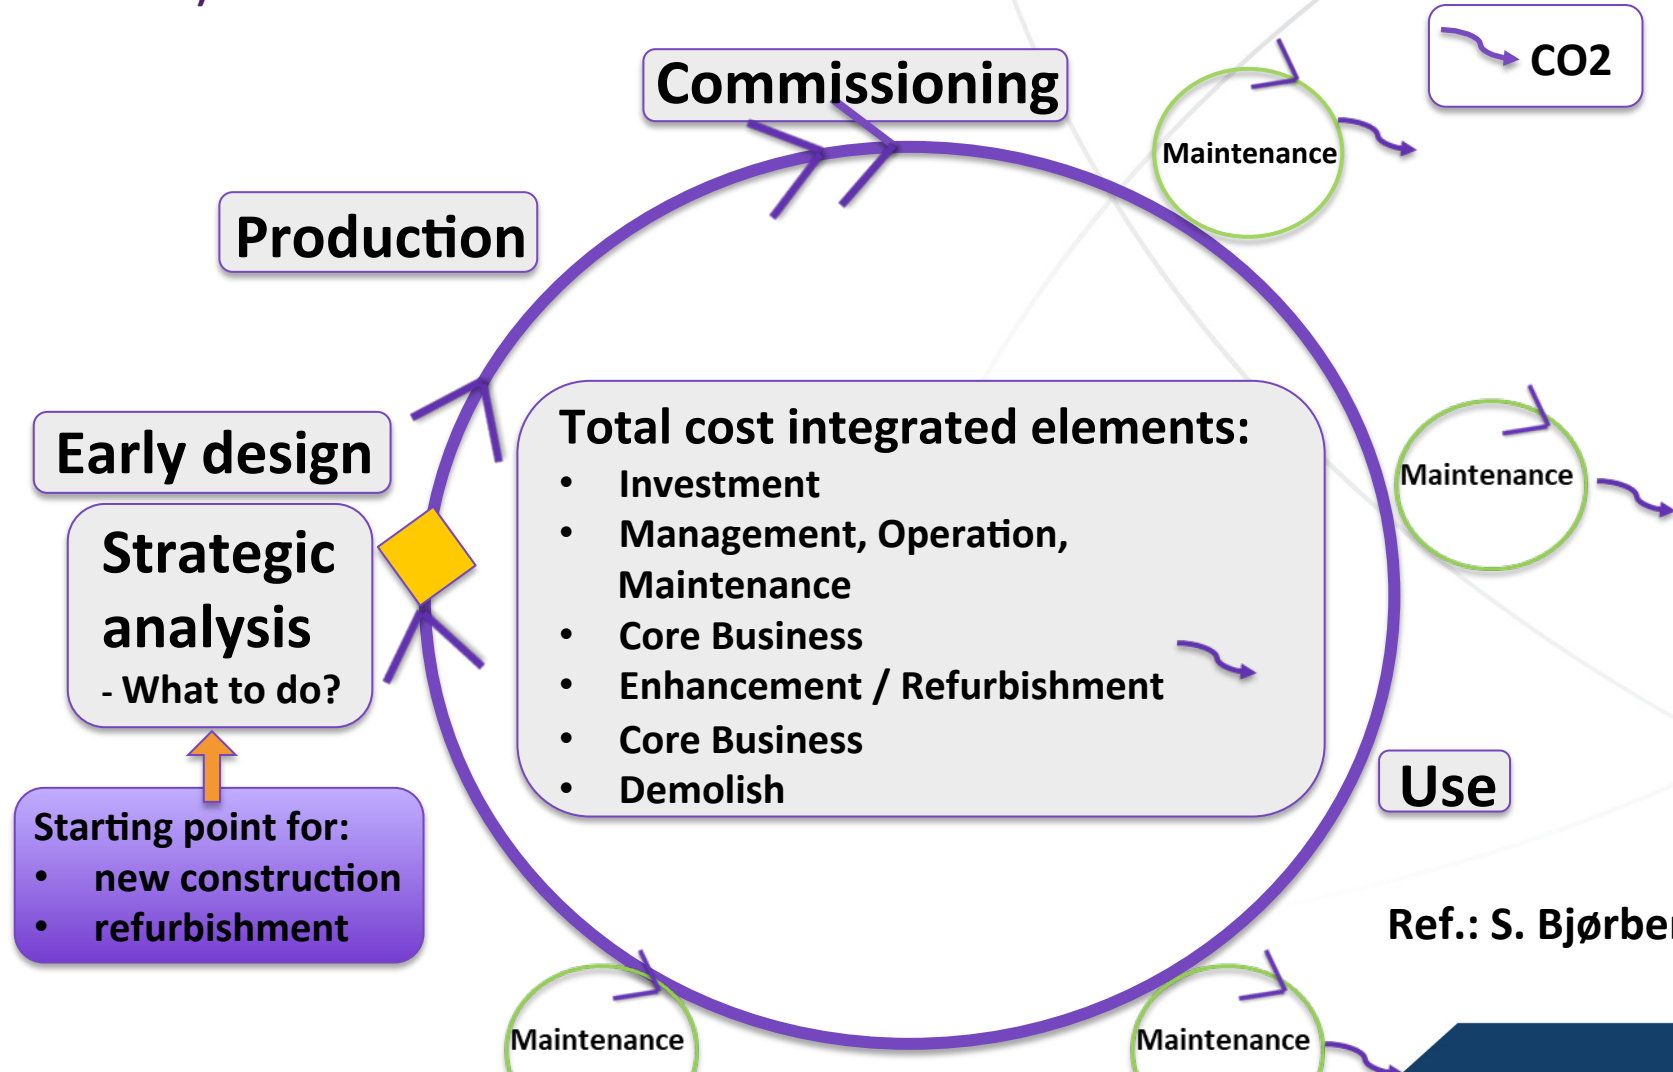
OSCAR GENERIC PHASEPLAN = CIRCULAR PHASEPLAN

(ANALYSIS-DESIGN-PRODUCTION-COMMISSION-USE- MAINTAIN - REFURBISHMENT-DEMOLISH)

Ref.: S. Bjørberg, 2017
